(6) National Dam Inspection Program.
LAKE HENRY DAM
Number
(NDI ID ~~PA-00366~~
DER ID ~~35-16~~),
Number.
~~PENNSYLVANIA GAS AND WATER COMPANY~~
Susquehanna River Basin, Lake Run,
Lackawanna County, Pennsylvania.
PHASE I INSPECTION REPORT

LAKE HENRY DAM

NDI ID No. PA-00366
DER ID No. 35-16

PHASE I INSPECTION REPORT
NATIONAL DAM INSPECTION PROGRAM

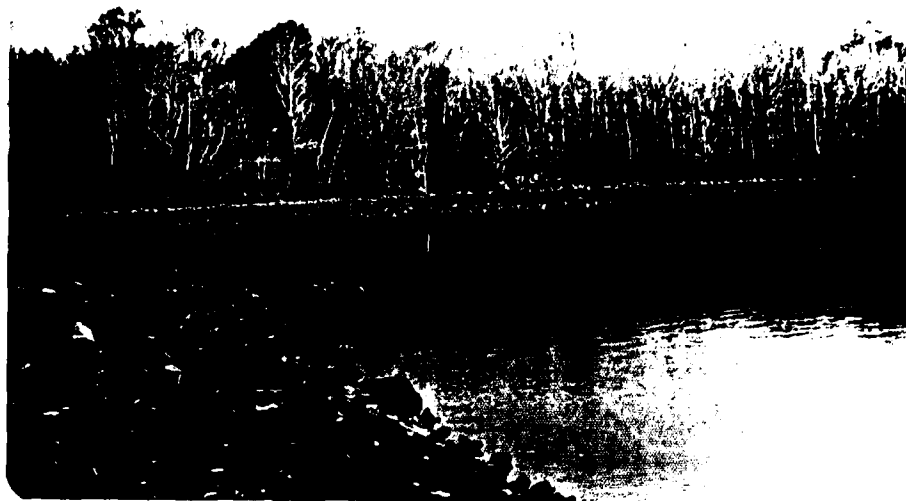
b. Embankments. Both embankments are thickly covered by ferns. The caretaker of the dam reported that this was a normal summer's growth. The brush had been cut the previous spring. Trees are growing at the toes of both embankments. The riprap on both embankments only extends up to the spillway crest. The riprap is in good condition. The tops of both embankments have low areas. The low areas extend over most of the tops of both embankments. The lowest point on the right embankment is 0.7 foot below the design top elevation; the lowest point on the left embankment is 0.6 foot below the design top elevation. The existing profiles are shown in Appendix B.

(2) Embankments. The brush on the embankments is sufficiently small that it presents no hazard to the embankment. It did hinder the visual inspection. Trees at the toes of the slopes are undesirable. The riprap not extending to top of dam is an erosion hazard.

A. Upstream Slope - Right Embankment

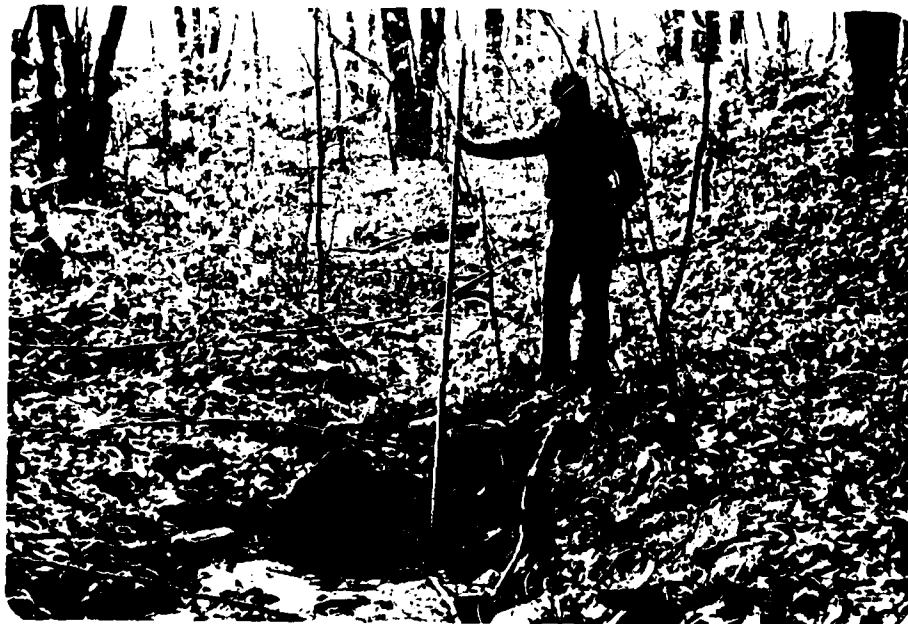
c. Appurtenant Structures. The outlet works is in good condition. On the day of the inspection, the outlet works valve was operated with no observed deficiencies. The outlet works pipe extends under pressure through the embankment. Clear seepage of 0.5 gpm was observed flowing from under the end of the pipe.

(3) Appurtenant Structures. The end of the outlet works pipe is 150 feet downstream from the embankment. The seepage observed at the end of the pipe is not excessive. It could be caused by either the natural ground water levels or by a leak in the pipe joints. Because the pool was low, the observed seepage was probably lower than that which would occur during normal pool conditions.

B. Outlet Works Outfall

(7) Monitor the seepage at the end of the outlet works pipe. The embankment should be inspected for seepage with the pool at spillway crest level. If changes are noted, take appropriate action.

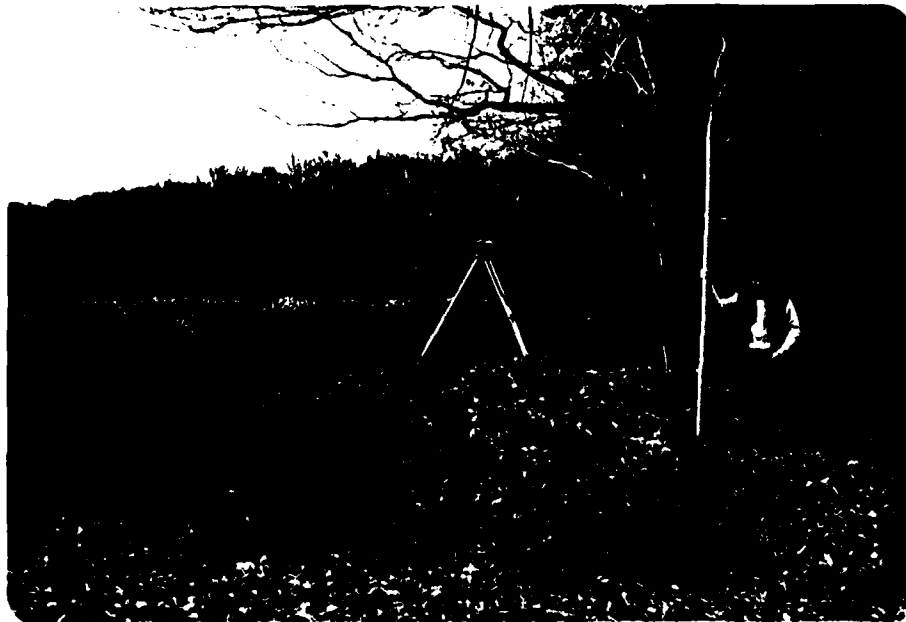
(2) Embankments. The low areas at the top of the embankments reduce the spillway discharge capacity. The low area of natural ground between the embankments will convey outflow before the embankments are overtopped. This may cause some erosion at the abutments of the embankments, and it is considered an erosion hazard. However, it is not felt that it would cause failure of the dam. Since the area acts as an auxiliary spillway, grading the area, clearing it of the minor amount of brush present, and protecting the ends of the embankments would appear to be warranted.

D. Low Area Between Embankments

- (3) Grade the low area between the embankments to provide better hydraulic control. Provide erosion protection at the abutments of both embankments.
- (4) Fill the hole at the end of the left embankment. Continue to observe the area. If changes are noted, take immediate remedial action.

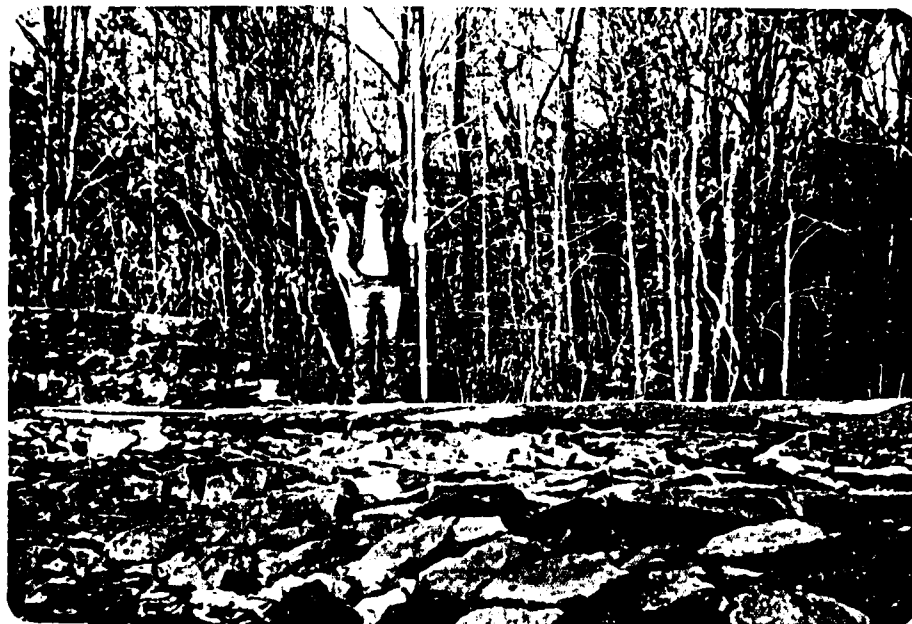
E. Spillway Approach

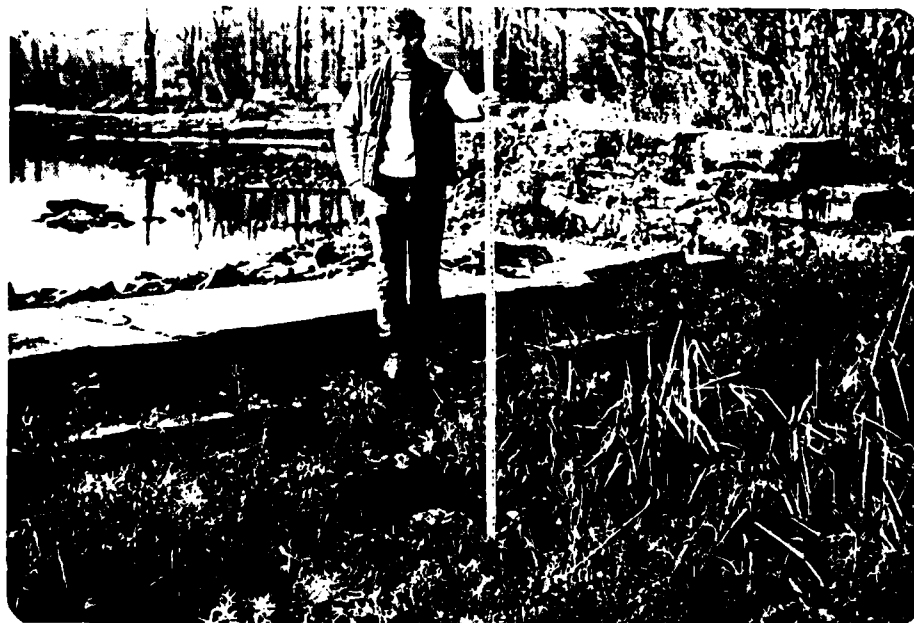
The masonry spillway is in fair condition. The mortar in the spillway walls is somewhat deteriorated. Thick brush is growing in the spillway apron. The stumps remaining from brush cutting are pushing up the paving in areas of the apron.

The deteriorated mortar in the spillway is an indication of the lack of maintenance.

F. Spillway

(6) Repair the mortar in the spillway walls and the paving in the spillway apron.
